Investigation on long-term progressive deformation of engineering slope based on comprehensive monitoring

Fig. 1 Slope zoning of the Tangba earth quarry of Changheba Hydropower Station.

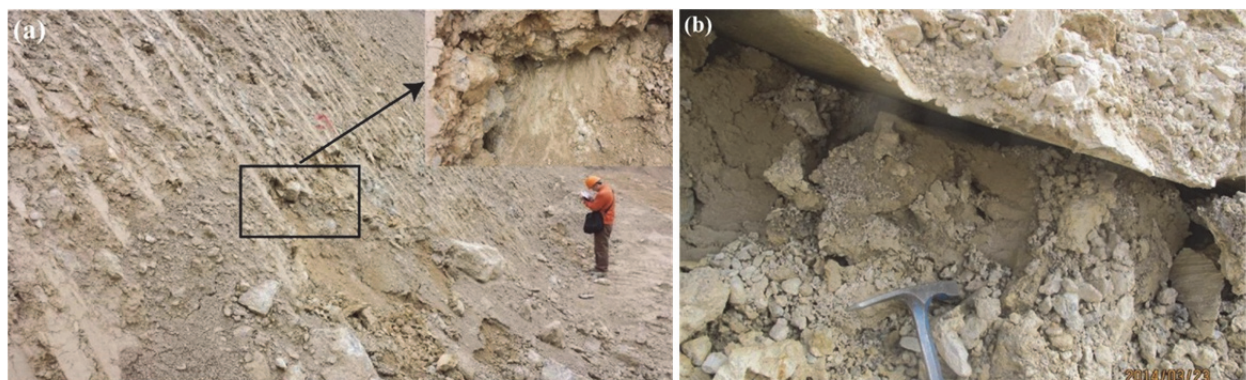
Quarry excavation activities started at the elevation of 2,260 m in Sept. 2013. The maximum gradient of excavated slope was nearly 1:0.5, and no support measures were conducted at the beginning period. The initial fractures were observed initially on Feb. 24th, 2014 at an elevation between 2,235 ~ 2,267 m. The tension fissures opened up to 50 cm in the posterior border. The deformation area extended rapidly to elevations of 2,118 m and 2,381 m at the bottom and top boundary, respectively, and multi persistent slide surfaces were formed gradually with shear outlets at the elevation between 2,118 m and 2,210 m (Fig. 2) at the end of Mar. 2014.

In Apr. 2014, the deformation mass at the elevation between 2,210 m and 2,385 m started to slide with a rate of 20~30 mm per day. The deformation rate increased up to 120 mm per day during the rainy season. The boundary of deformation mass reached to elevation of 2,405 m in Oct. 2014. The dam fillings and quarry excavation activities finished on May 9th, 2016. After that, the upper part of slope (higher than elevation of 2,360 m) was reinforced in Sept. 2016 and could basically keep the

Fig. 2 Deformation conditions of the Tangba earth quarry slope in Mar. 2014. (a) Shear outlets at the elevation of 2,120.0 m; (b) Shear outlets at the elevation of 2,210.0 m.

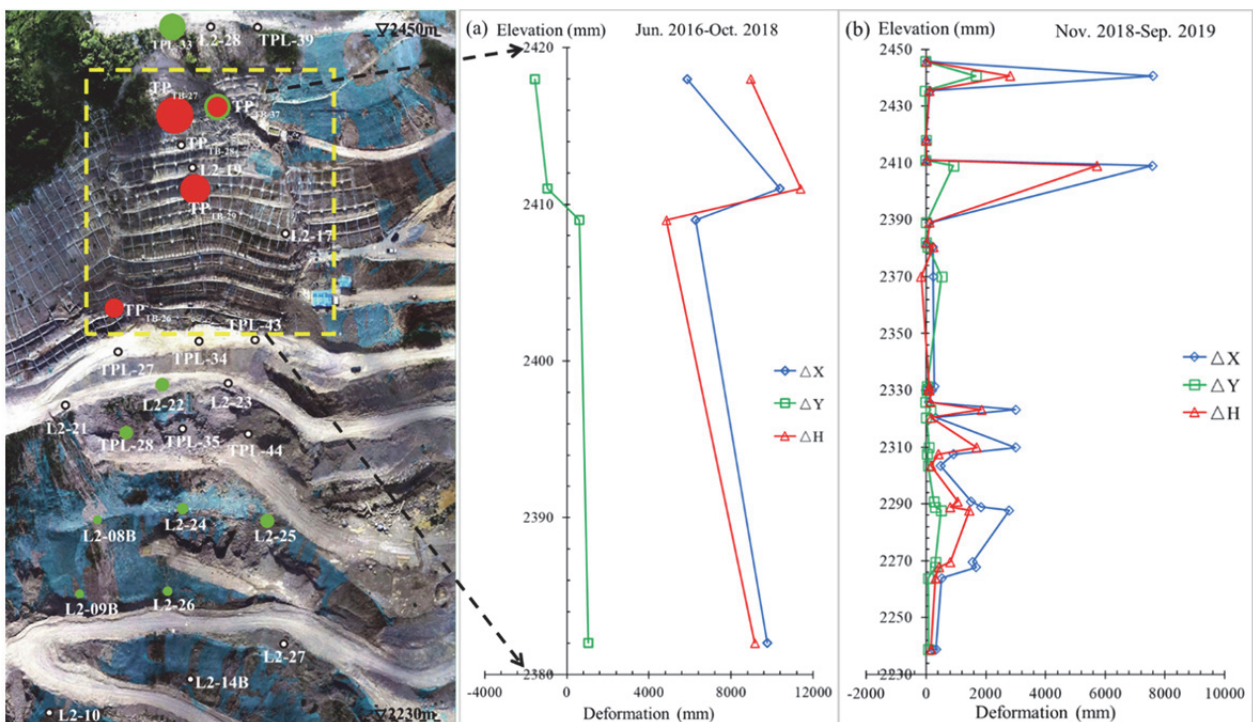
Fig. 4 Continuous monitoring results of Tangba earth quarry slope surface deformation during (a) period from Jun. 2016 to Oct. 2018 and (b) period from Nov. 2018 to Sep. 2019. (Displacements of monitoring point larger than 1 m are denoted as red and green solids respectively, and the larger the radius, the larger the displacement.)

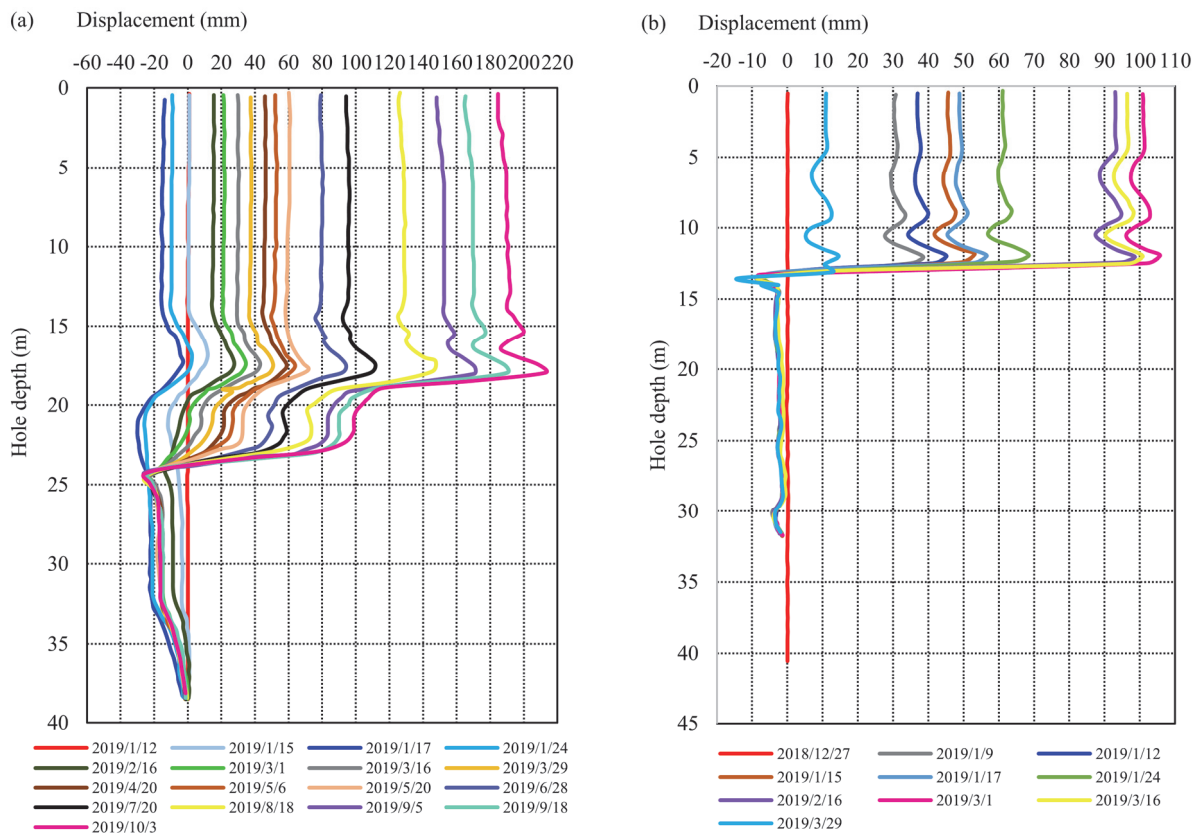
The positive values of data indicate the displacement toward free face. The monitoring results show that the displacements in the slope crest (zone A) are less than 3.0 cm at depth of 0-20 m during the period of 2015 to 2019. The monitoring data at the toe of zone B (INTB-20 with the borehole head at the elevation of 2234.33 m) show that the maximum displacement of 1.3 cm occurred at the borehole depth of 1.0 m in the period of Dec. 2018 to Sep. 2019 (the whole monitor depth is about 42.0 m).

The upper section of the slope zone B (higher than El 2360) was supported at the end of excavation in May 2016, and after that, the supported zone B was basically stable during the period of May 2016 to Mar, 2018. On the other hand, a slow creep deformation occurred in the zone at elevation of 2,100~2,360 m, which indicated that it was in a critical equilibrium state in the same period.

Fig. 5 Displacement at varied depth in subsurface of slope in 2019. (a) the lower location of zone B; (b) the upper location of zone B.

For the safety of cultivated land utilization, the deformed blocky rock masses and loose debris should be removed on the shallow surface of slope. The slope flattening and reinforcement for the lower section of zone B (lower than El 2360m) began in Mar. 2018. The excavation activities at elevation of 2,330~2,360 finished on May 12th 2018, and then some temporary supports were installed on shallow superficial layer of slope. From Jul. 8th to 17th 2018, the excavation

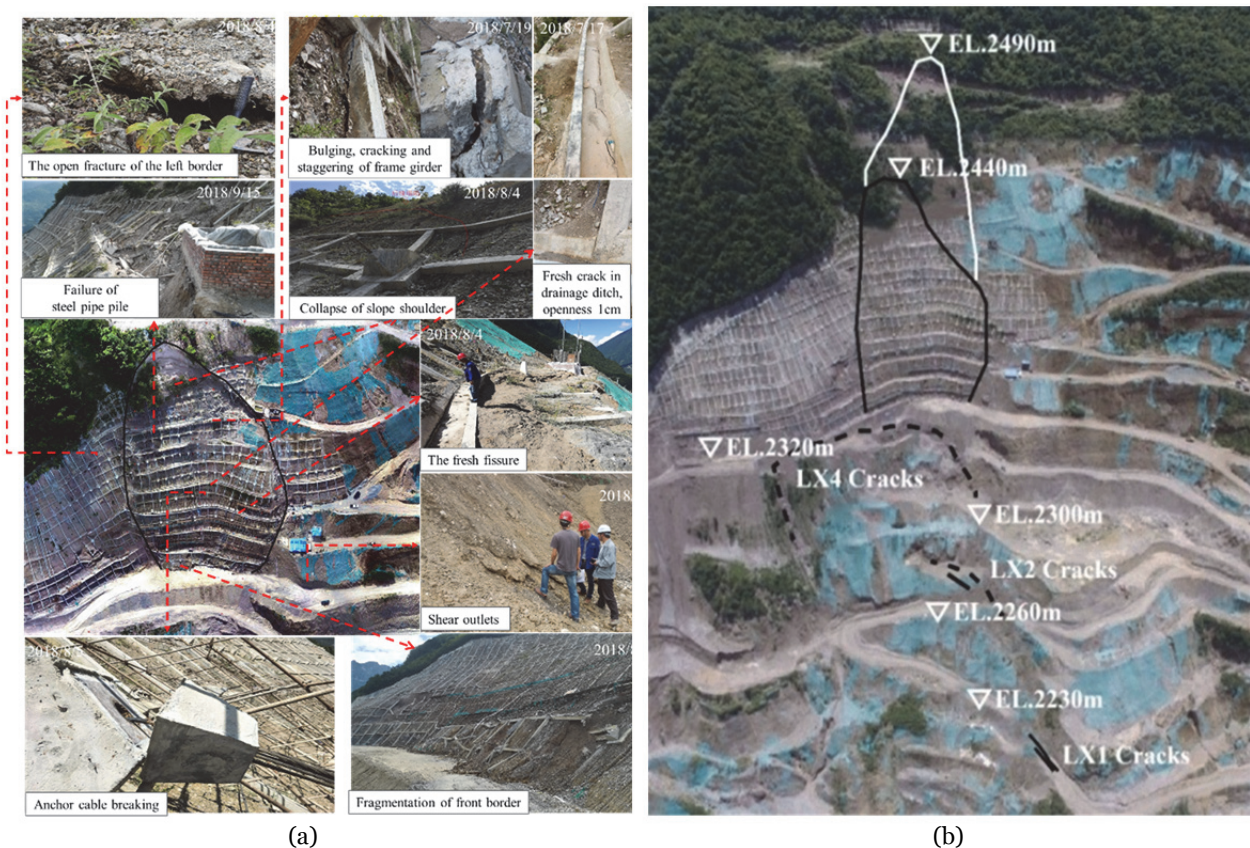
activities continued at the elevation of 2,330 m~2,320 m. Obvious fractures as well as increasing monitoring displacements appeared immediately and expanded progressively. The process of progressive failure is shown in Table 2 and Fig. 6a.

Following the slope failure process depicted in Table 2, a successive deformation occurred in the left upper part at elevation of 2,440~2,490m after 5-days persistent precipitation from Sept. 29th to Oct. 4th 2018 (Fig.6b). The deformation rate were about 50~100 mm/d in Oct. 1st ~ 3rd, and reached 200-460 mm/d in Oct. 4th ~7, 30~160 mm/day in Oct. 8th ~25th, 5~22 mm/d after Oct. 26th 2018. It indicated that the new deformation event also experienced a process of fracture initiation and propagation, slip initiation and acceleration, post-peak slippage, and residual deformation. As of Dec. 18th, 2018, the monitoring data showed that the slope had a downward displacement of 3.1 m at elevation of 2481m, and 6.32 m at elevation of 2,409 m. Besides, some initial fractures occurred at elevation 2,490~2,520 m, while no deformation signs were observed beyond elevation 2,520 m.

| Deformation stage | Time range | Deformation phenomenon | Deformation rate (mm/d) | |
|---|---|---|---|---|
| Sliding surface formation | 2018/7/19-8/6 | A total of 28 fresh fissures were observed according to the site survey on Aug. 5 th . Some fissures have openness of 5~20cm, which confined the boundary of deformation mass. The support structures in the deformation mass were damaged and even failed. It indicated that a connected slide surface is formed gradually. During this period, the slope deformed or slipped with a stable rate. | 2018/7/23 | 35 (maximum) |
| Post-peak slip | 2018/8/13-8/28 | The frame girder, and anchor cable along the boundary of deformation mass had been broken completely, especially the leading edge where the anchor cable had a dislocation of 2.5 m | 2018/8/13-8/28 | 100~200 |
| Residual stage | 2018/8/28-9/15 | The total deformations were 8.9 m and 5.6 m along the h and x-direction of the back edge, and 3.0 m and 11.0 m respectively at the front edge. The dip angle of slope cliff was about 60° as surveyed on Sept. 3 rd 2018 | 40~90 | |

Fig. 6 Deformation features based on field investigation of the Tangba earth quarry slope from July to October in 2018. (a) The fracturing process. (b) The eventual failure area.

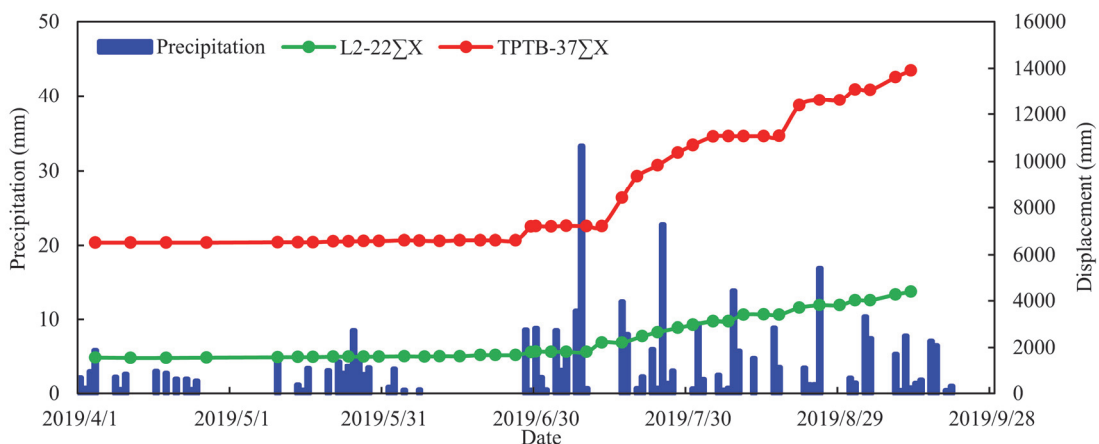
The comparison of monitoring data signified that the slope deformation and had a positive correlation with the precipitation process. Meanwhile, no engineering activities or other events that affected stability were put forward in 2019. Thus, rainwater was regarded as the facultative factor that promoted the deformation initiation and growth in this period. The rainwater permeated the rock-soil interface through cracks, which can reduce the effective stress and weaken the material strength of the interface layer. This process gradually weakened slope

Fig. 7 Comparison between precipitations and cumulative deformation at direction of slope free surface (ΣX) of TPTB-37 in zone B and L2-22 in zone C between April to September in 2019.

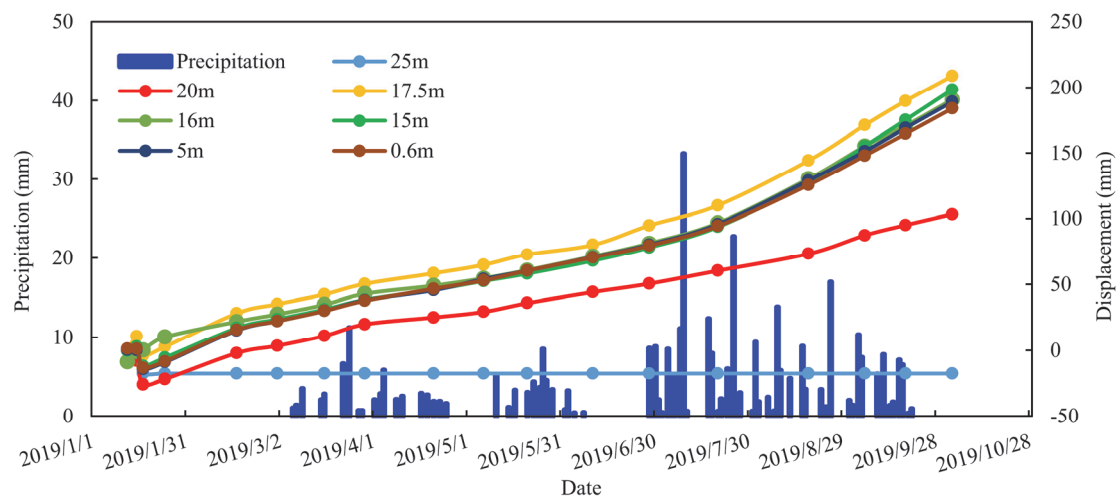
Based on the deformation at different depth of a borehole derived from Device No. INTB-17 (the location can be tracked in Fig. 5a), the comparison between the interior displacement at different depths and rainfall in 2019 are shown in Fig. 8. The results show that the displacements slightly increased with a rate of about 8 mm per month before June, while with much higher rates of about 40 mm per month during Jun. to Sept. for the points with depth shallower than 20m. On the other hand, the monitoring data had barely changed at depth of 25m, which indicated the depth of sliding face was between 20m ~ 25m in this borehole. As the precipitation increased obviously in the period between Jun. and Sept. 2019, the deformation interior slope also increased.

Fig. 8 Comparison between the interior displacement at different depths as well as precipitation of INTB-17 in zone C during January to October in 2019.
