Investigation on long-term progressive deformation of engineering slope based on comprehensive monitoring

Fig. 1 Slope zoning of the Tangba earth quarry of Changheba Hydropower Station.

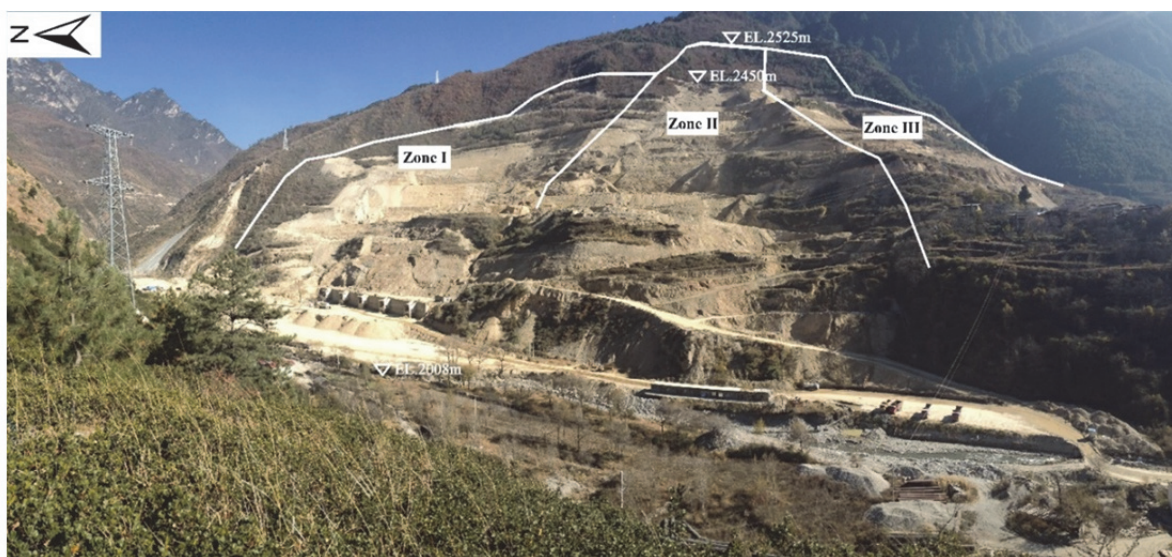
As depicted in Fig. 1, the Tangba earth quarry could be divided into three slopes of I, II, and III from downstream to the upper stream. The slopes I and III were basically stable for the relatively gentle terrain, while the deformation mainly occurred in slope II.
